Naval Research Laboratory

NRL/MR/6180-92-7145

## Findings of Portable Air Mover Tests on the ex-USS SHADWELL

September 30, 1992

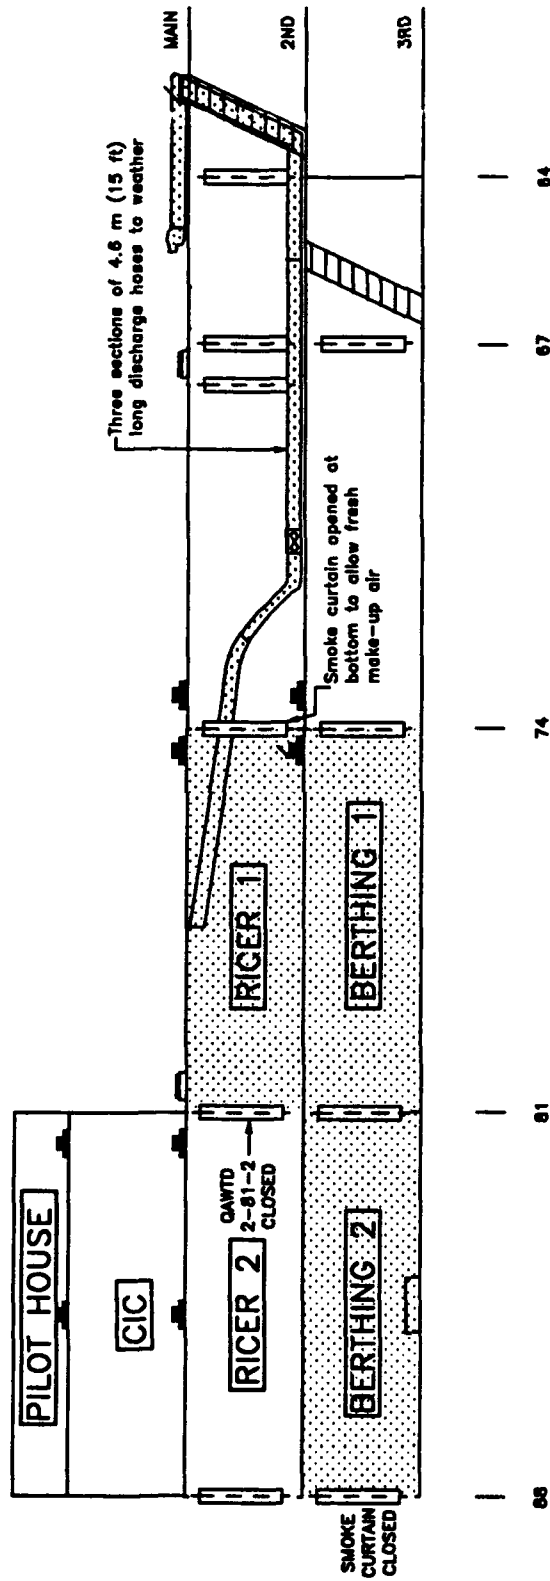
Fig. 13 - Section view, static test, unmanned desmoking

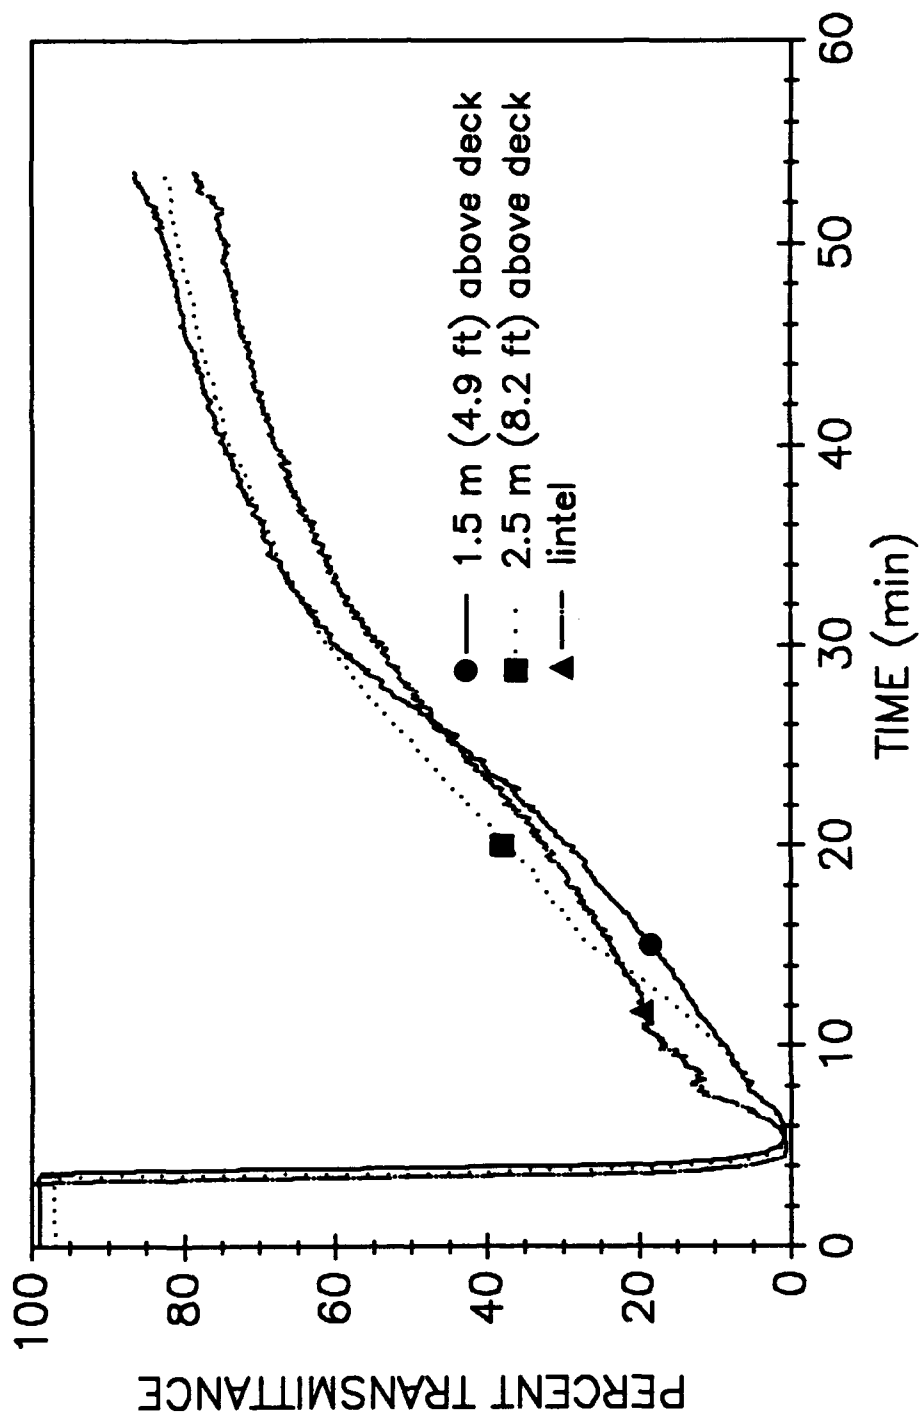
Fig. 15 - Percent transmittance in BERTHING 1 during FAN\_10  
using Red Devil 20.3 cm (8 in) duct

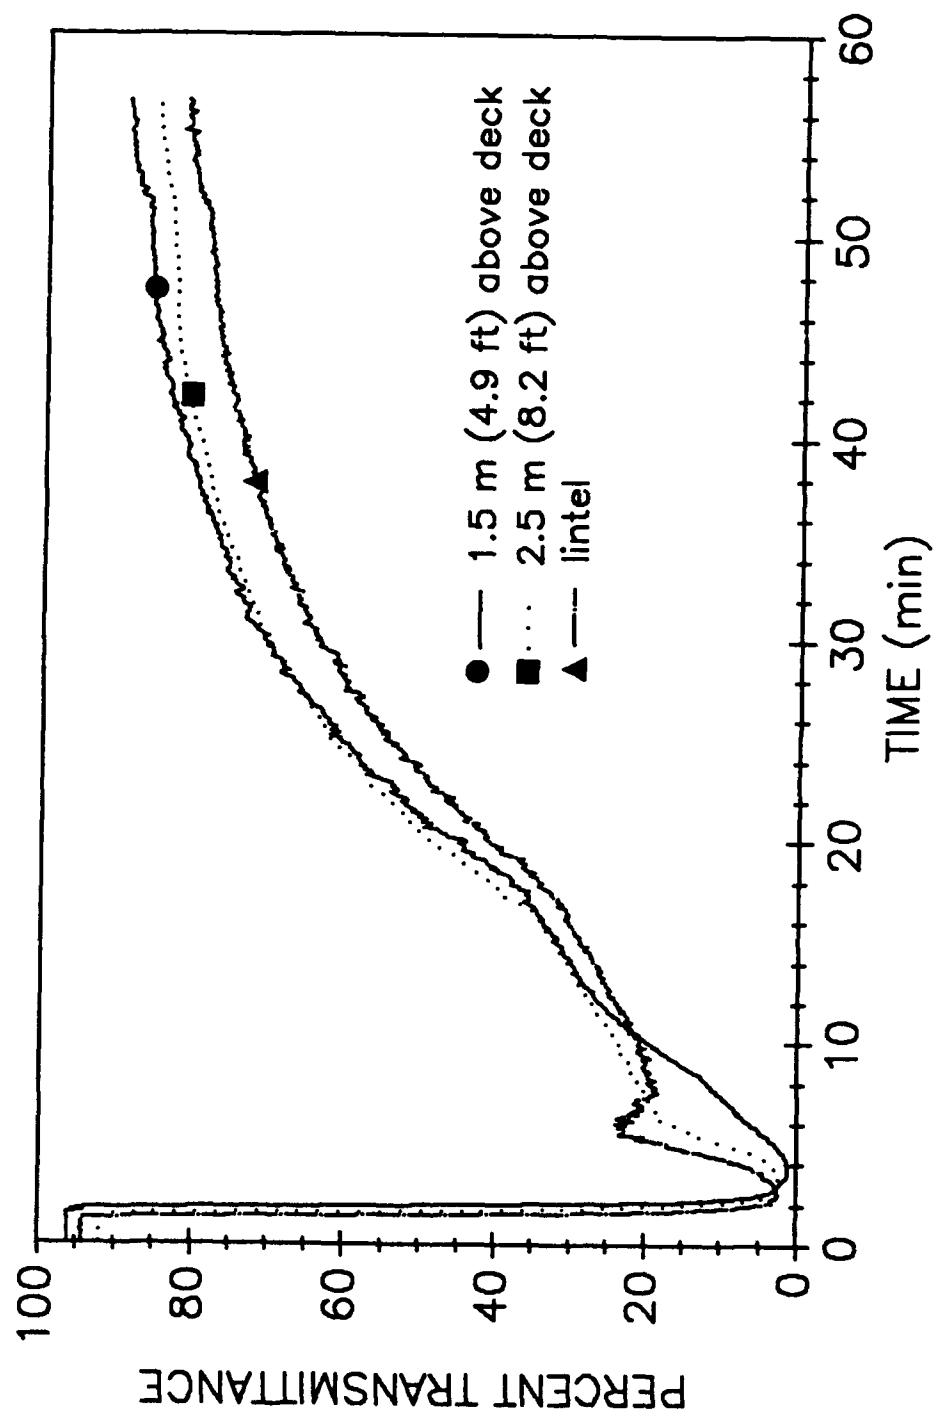
Fig. 16 - Percent transmittance in BERTHING 1 during FAN\_12  
using Red Devil 25.4 cm (10 in) duct

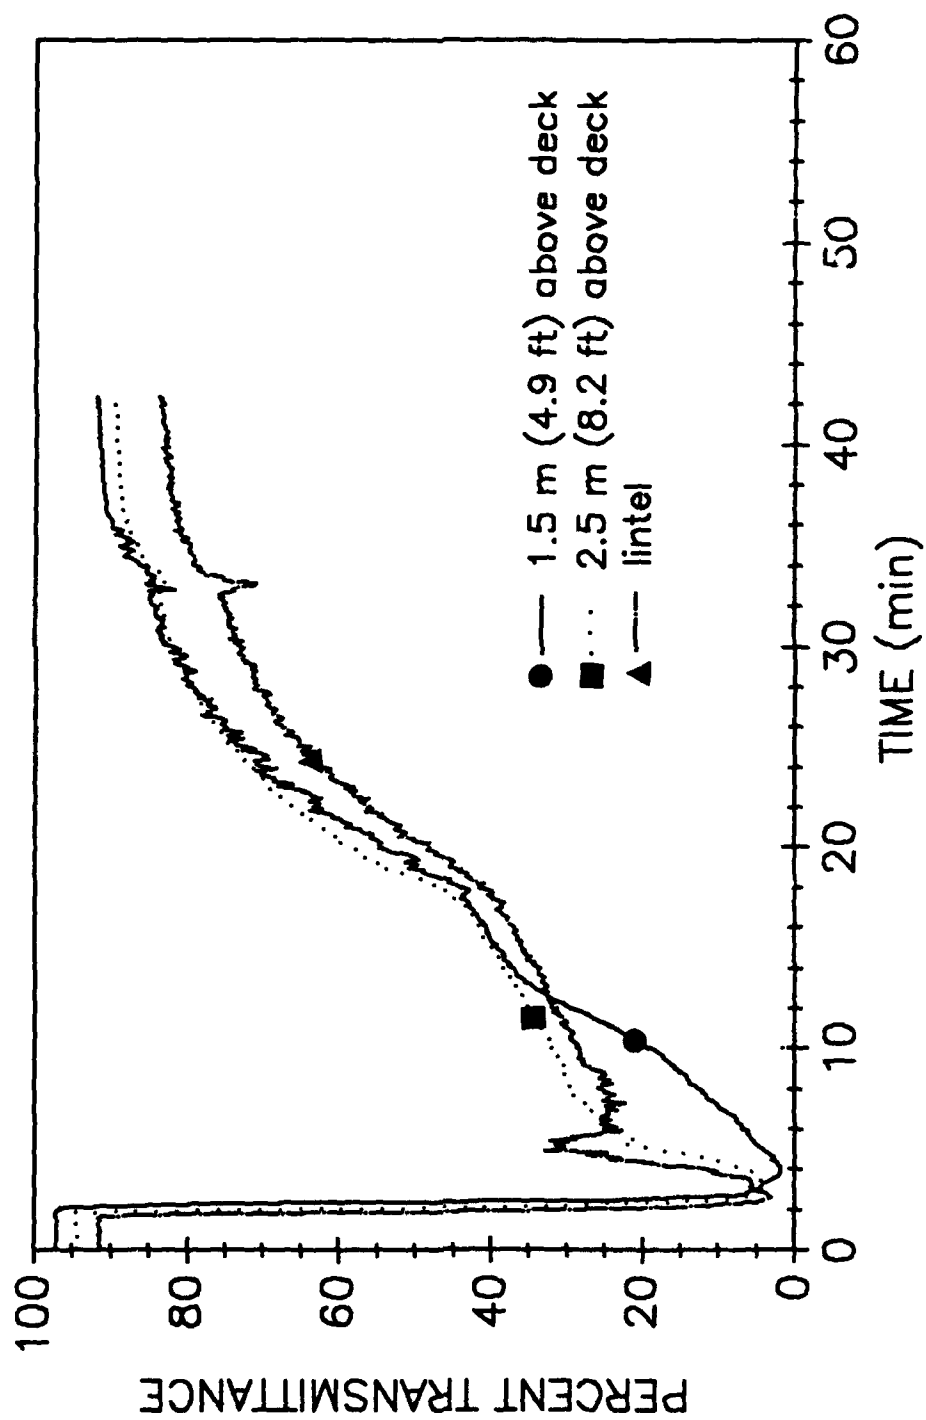
Fig. 17 - Percent transmittance in BERTHING 1 during FAN\_15  
RAMFAN 345 kPa (50 psi)

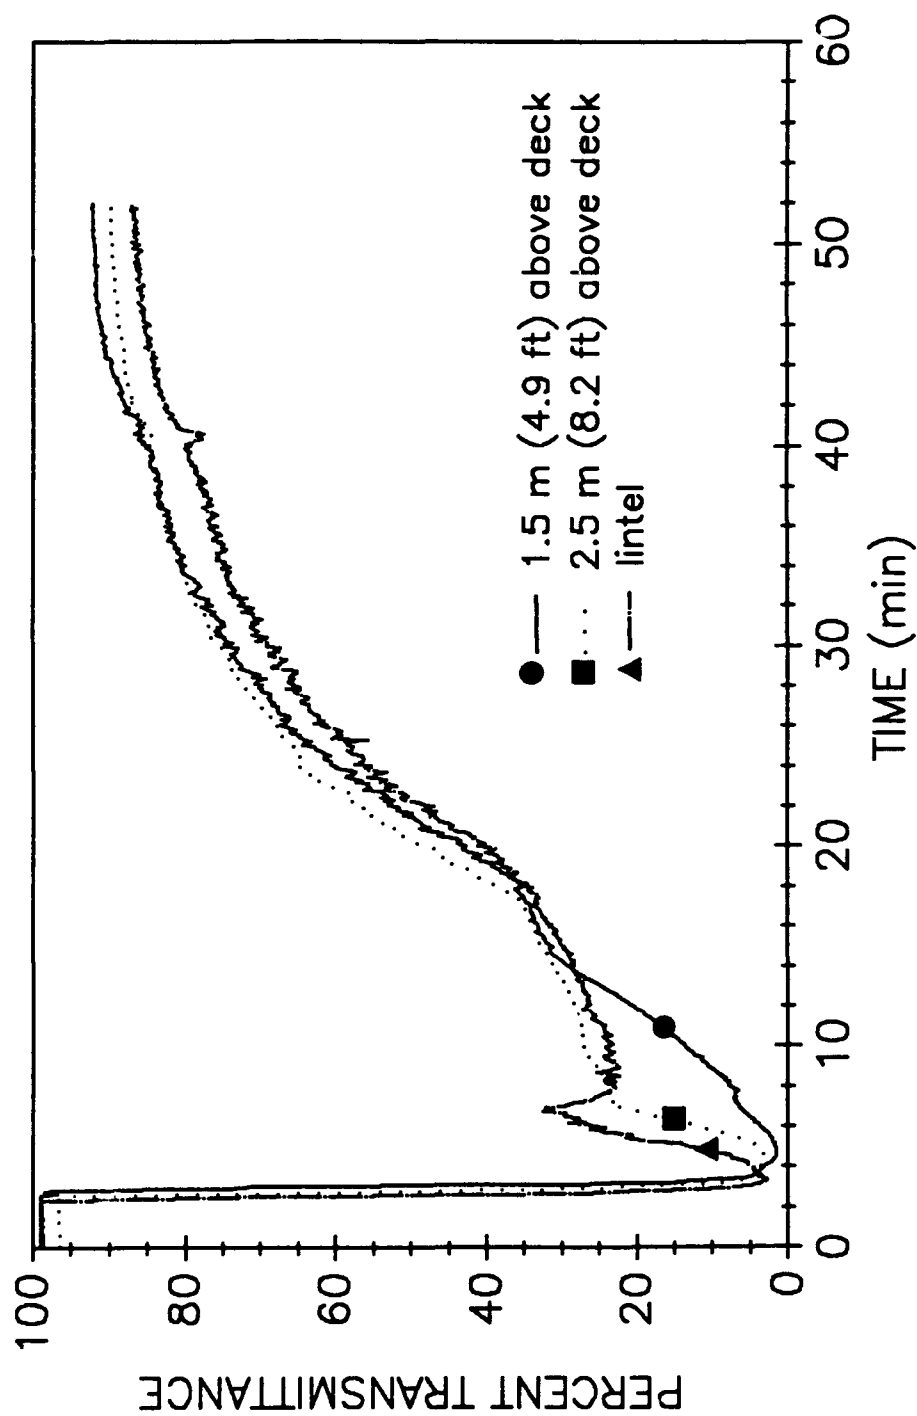
Fig. 18 - Percent transmittance in BERTHING 1 during FAN\_16  
using Red Devil 25.4 cm (10 in) duct

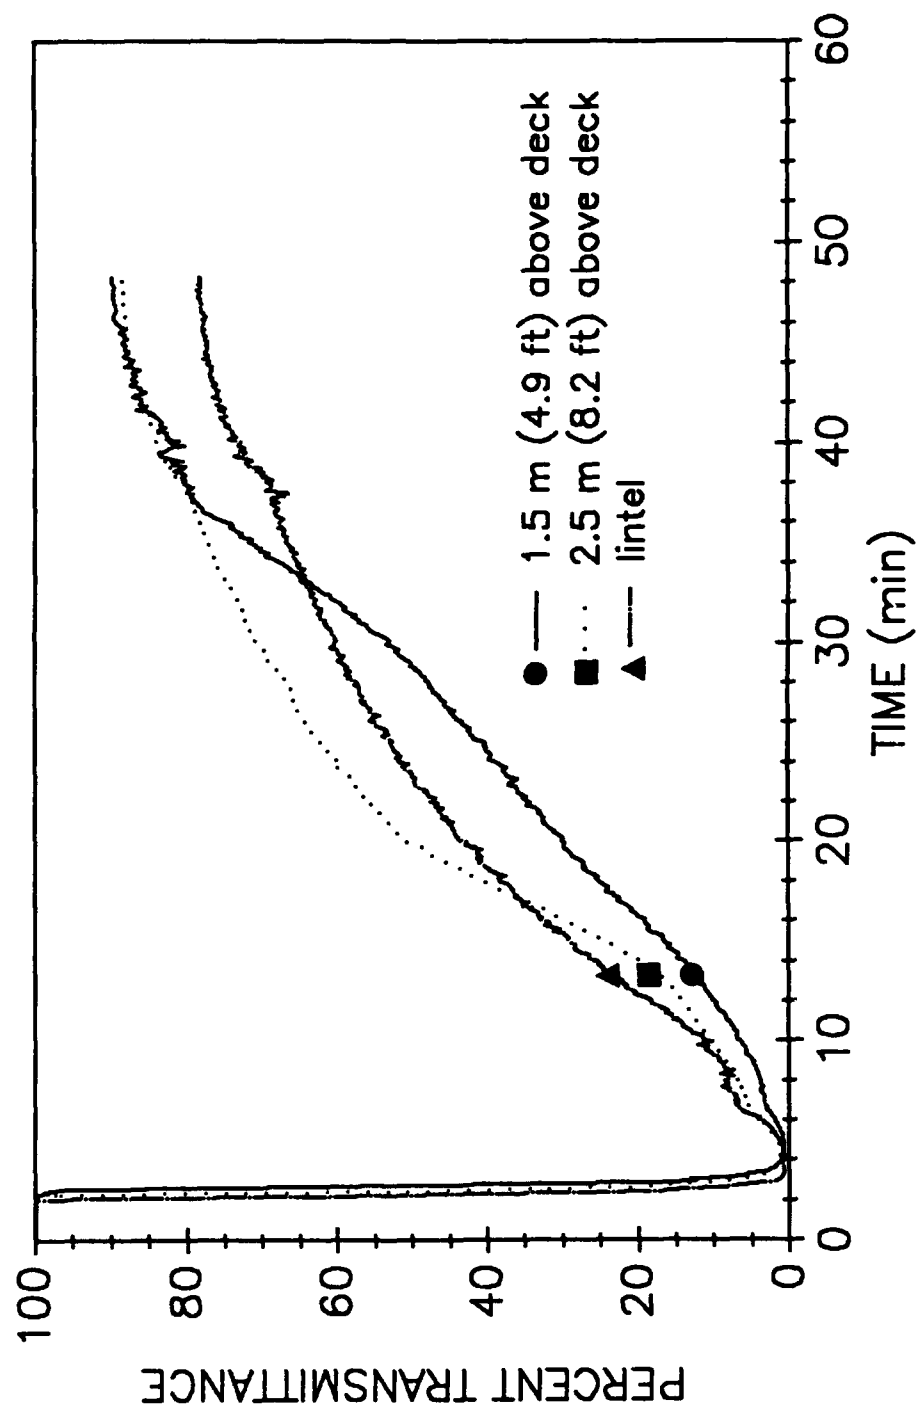
Fig. 19 - Percent transmittance in BERTHING 1 during FAN\_17  
using Red Devil 20.3 cm (8 in) duct

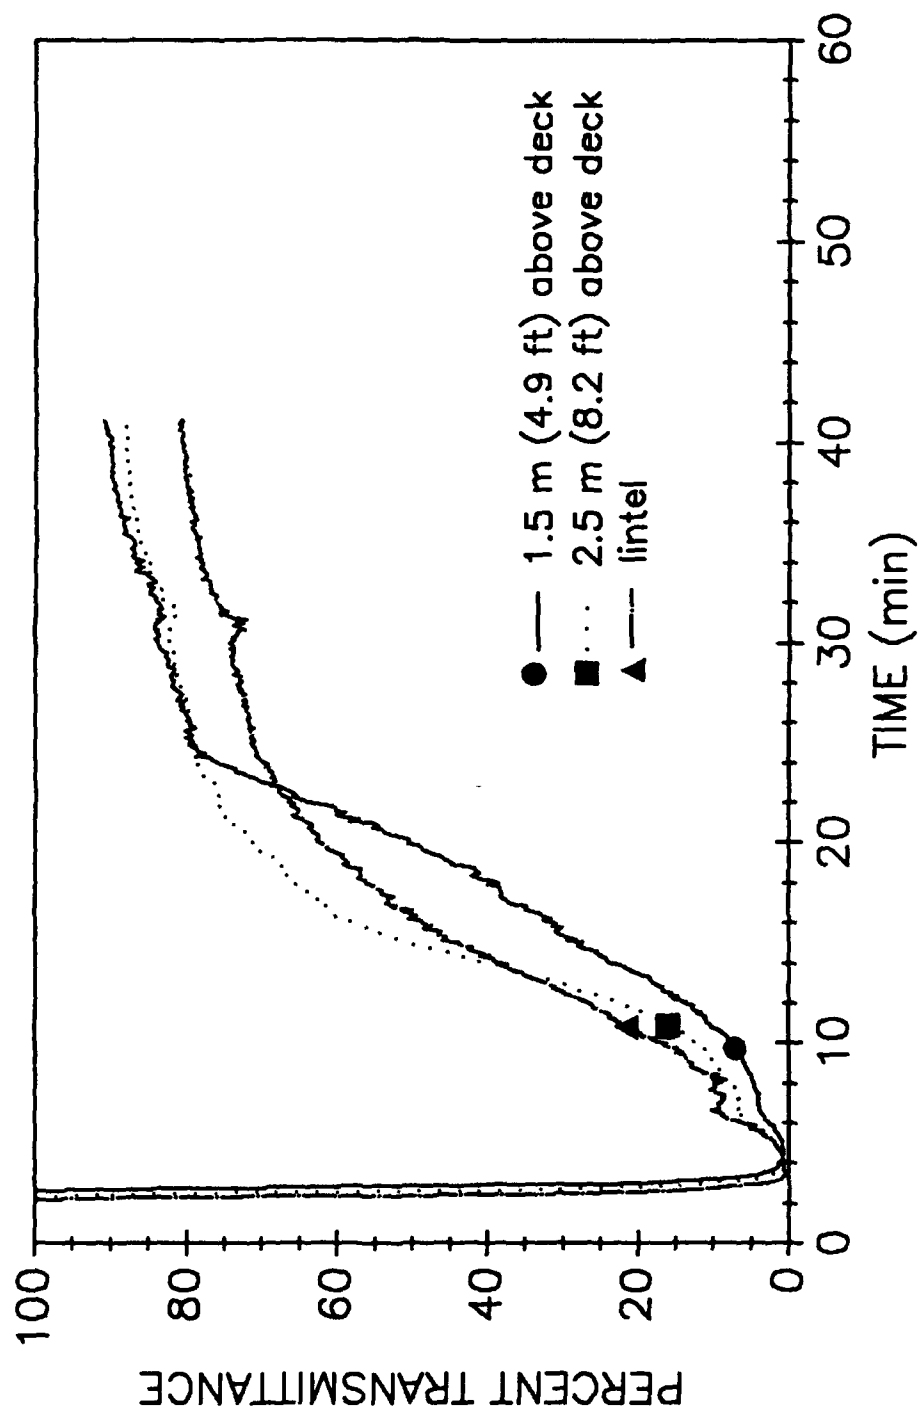
Fig. 20 - Percent transmittance in BERTHING 1 during FAN\_18  
using RAMFAN 956 kPa (140 psi)

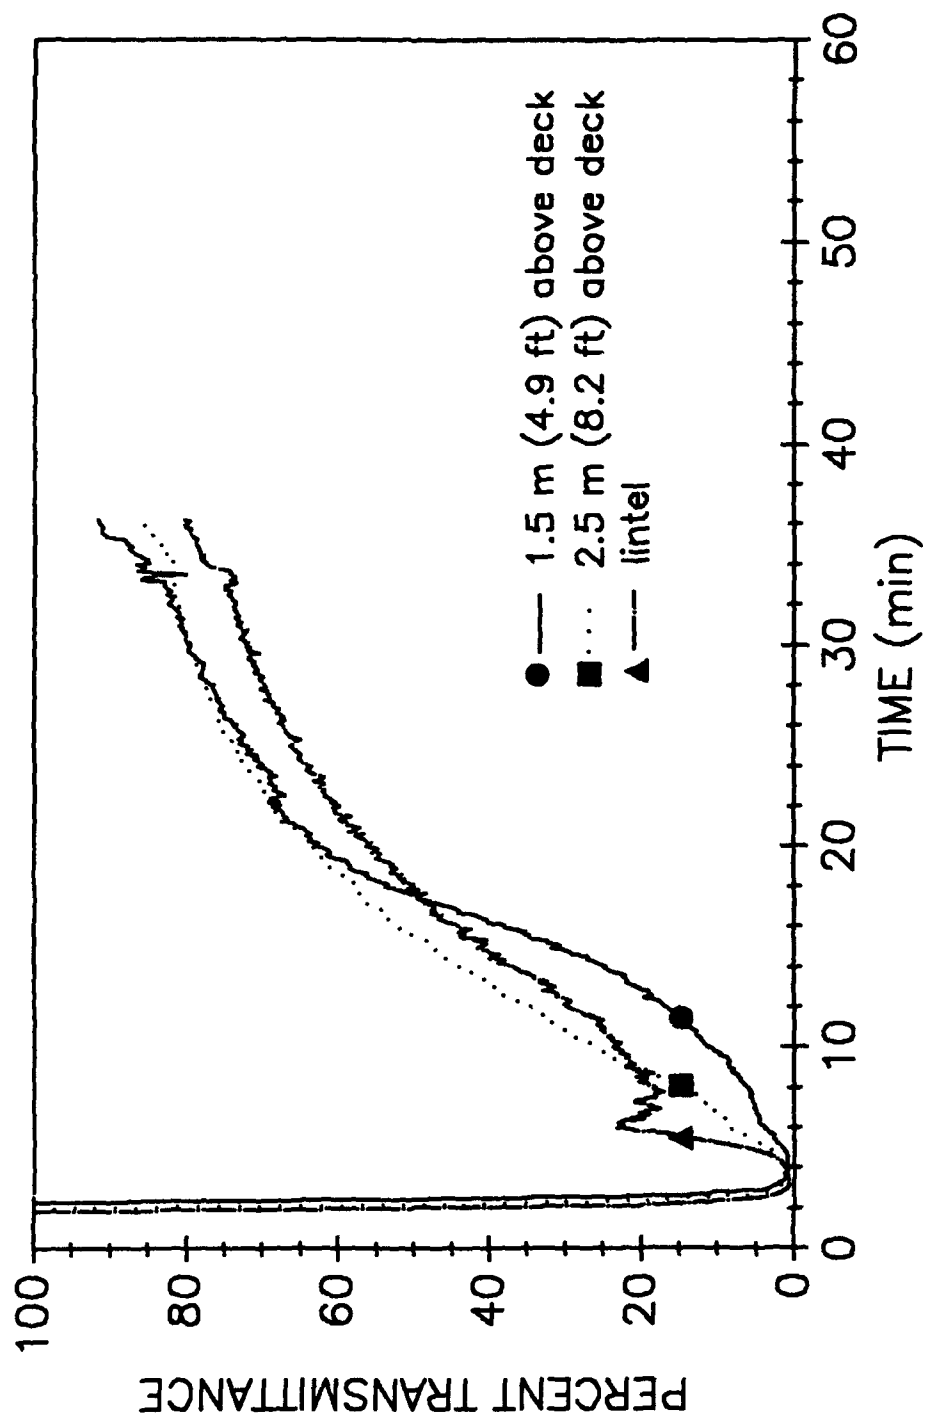
Fig. 21 - Percent transmittance in BERTHING 1 during FAN\_19  
using Red Devil 25.4 cm (10 in) duct

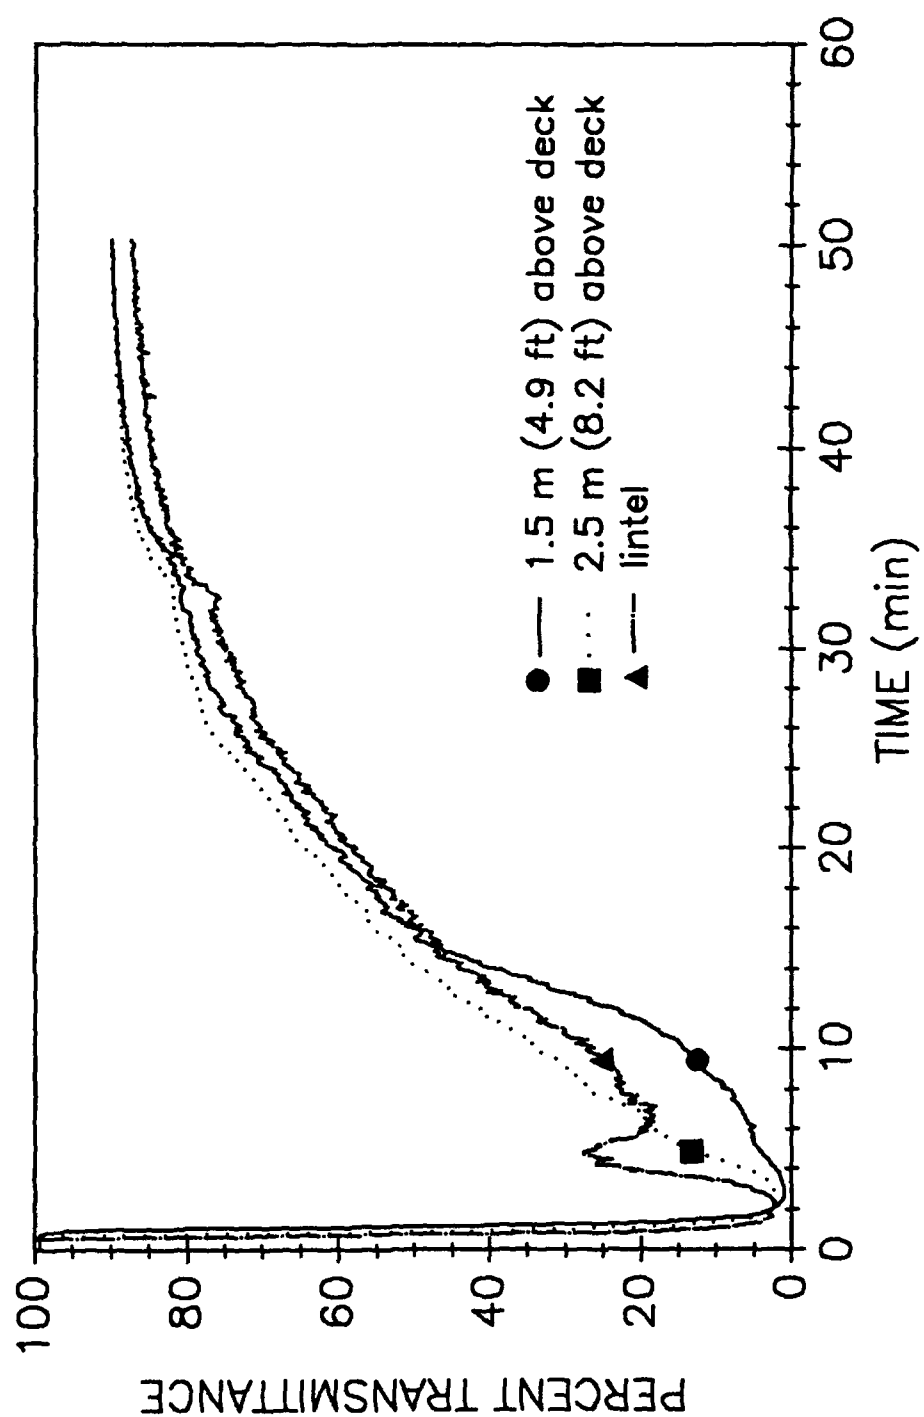
Fig. 22 - Percent transmittance in BERTHING 1 during FAN\_20  
using RAMFAN 345 kPa (50 psi)

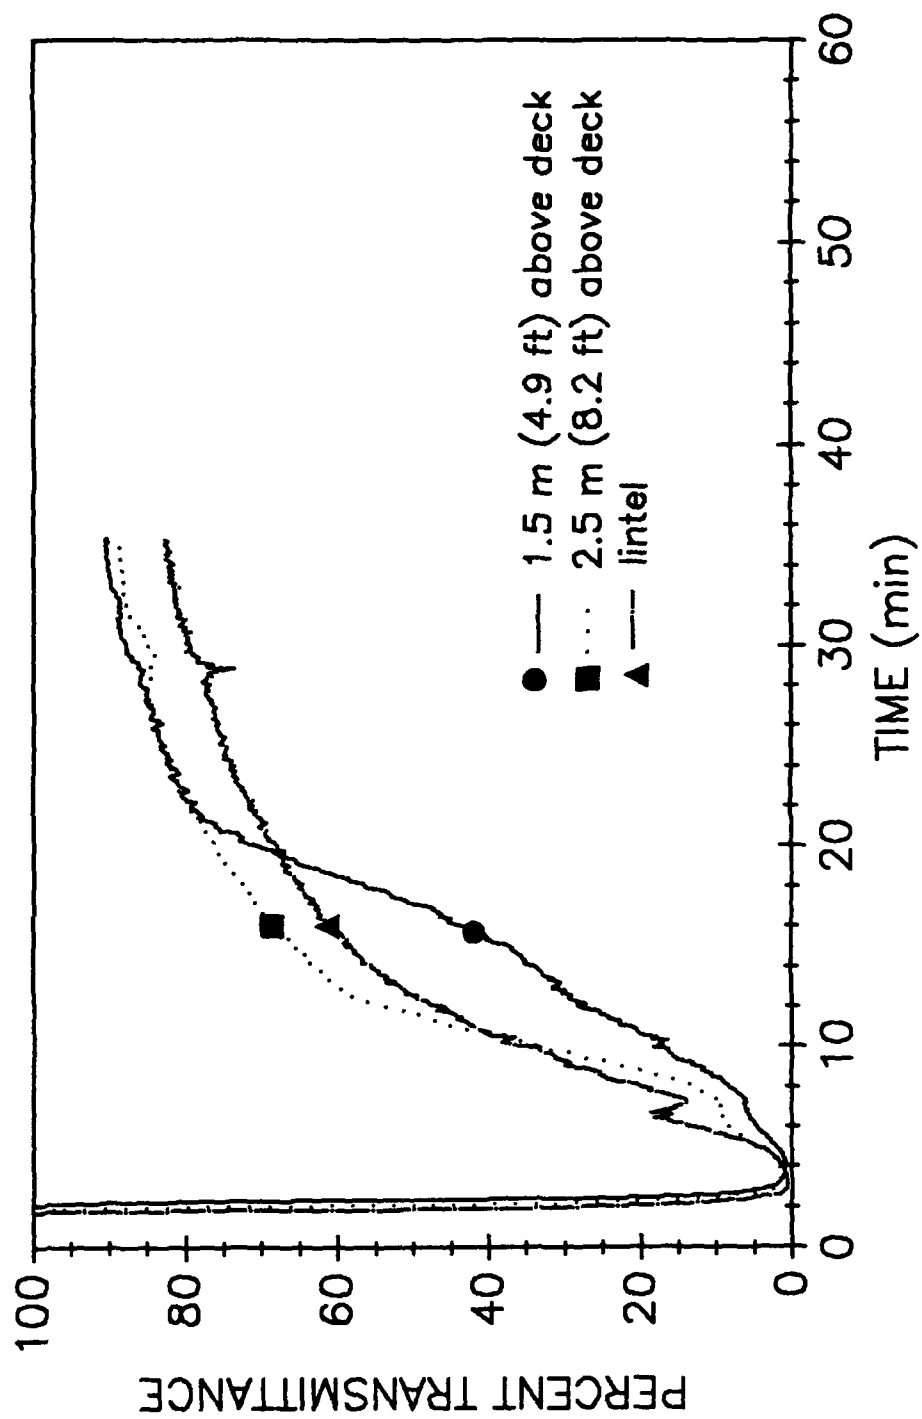
Fig. 23 - Percent transmittance in BERTHING 1 during FAN\_22 using RAMFAN 1000 kPa (145 psi)

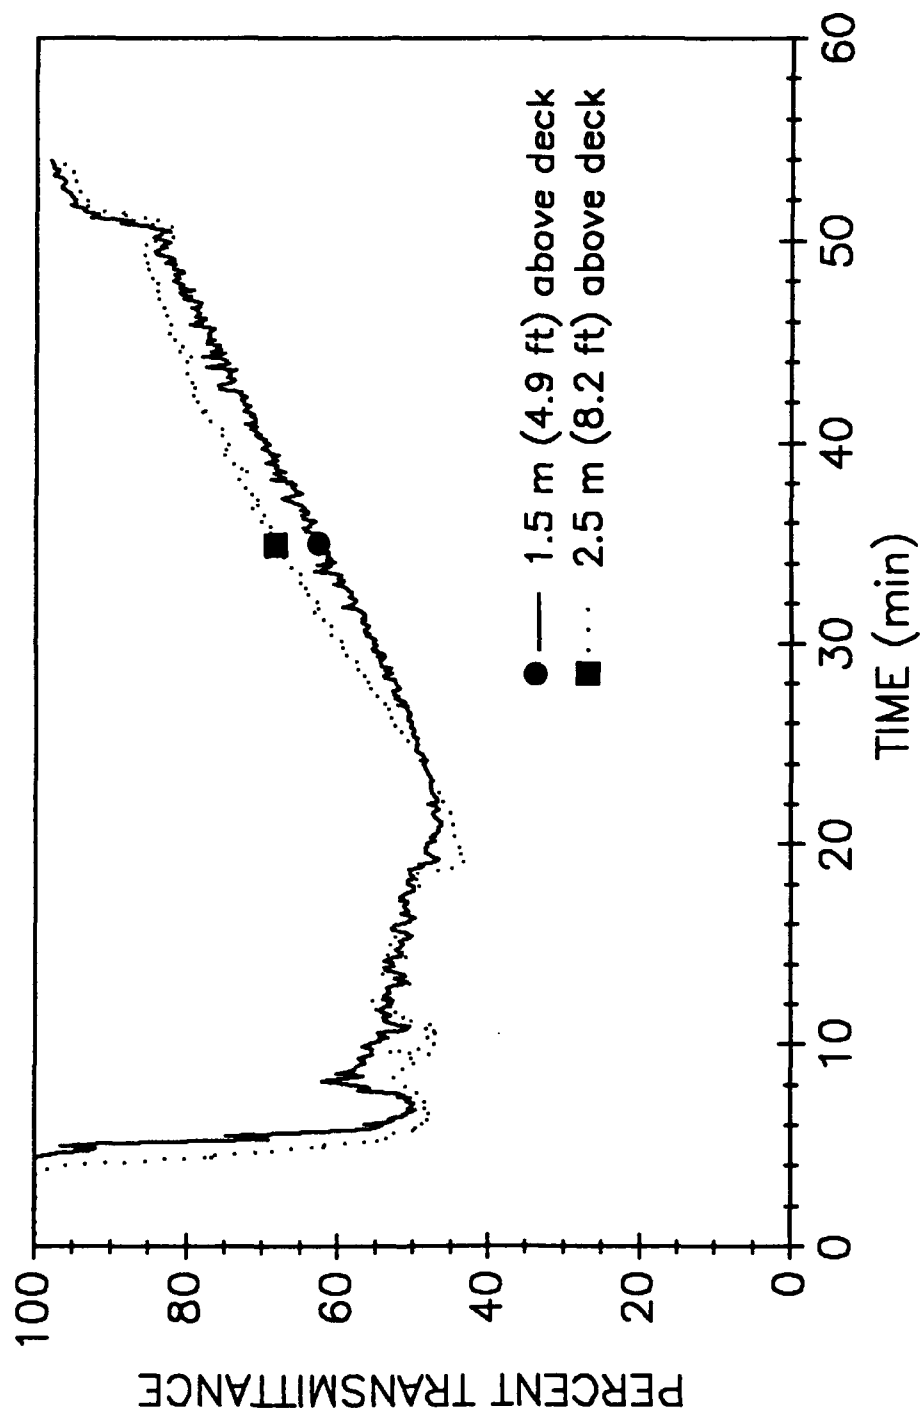
Fig. 24 - Percent transmittance in RICER 1 during FAN\_10  
using Red Devil 20.3 cm (8 in) duct

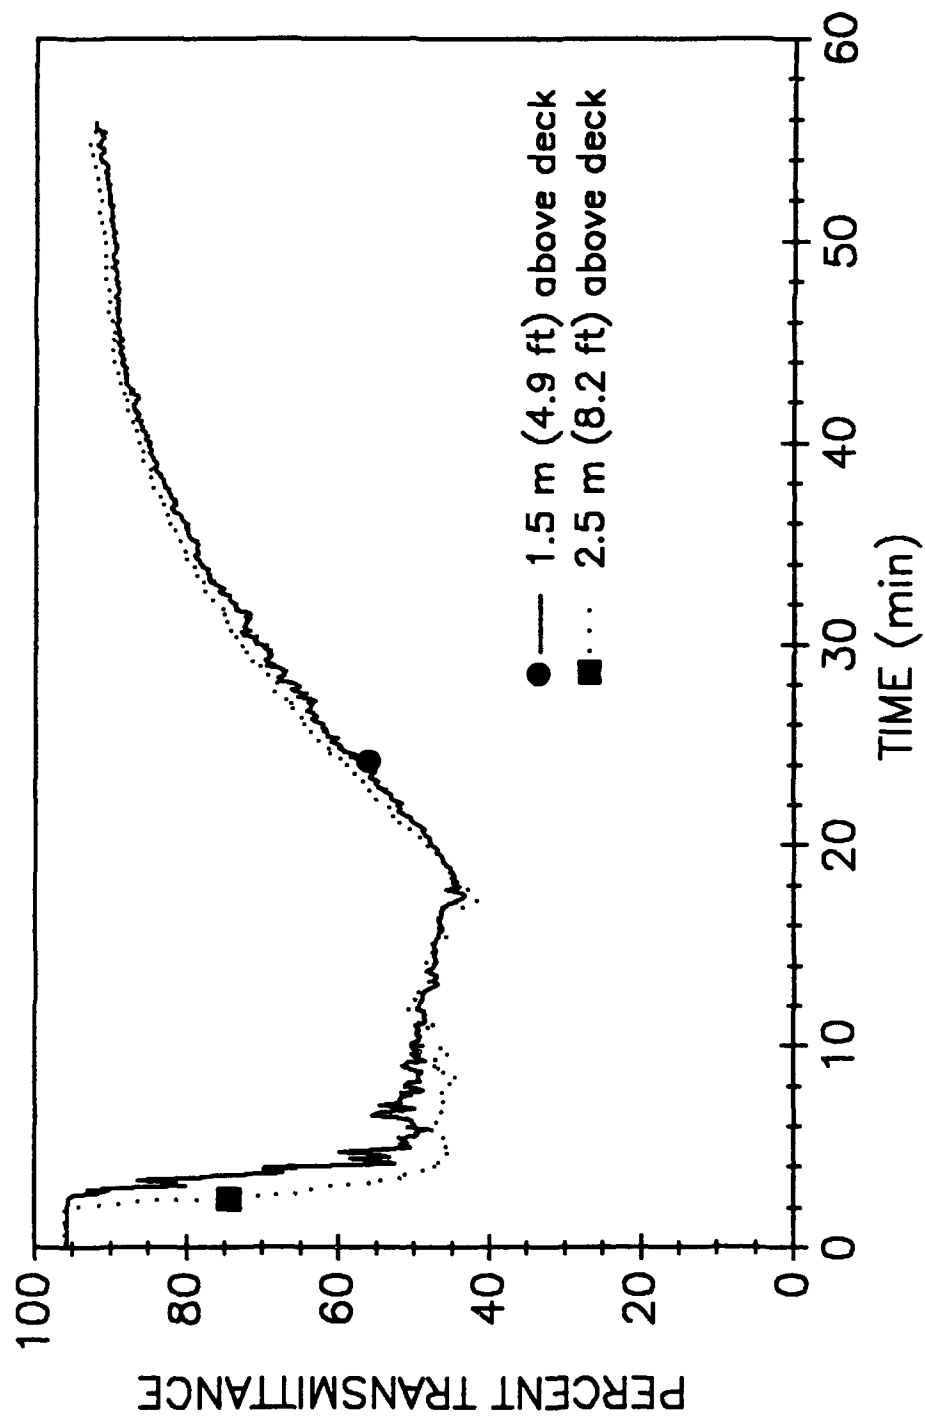
Fig. 25 - Percent transmittance in RICER 1 during FAN\_12  
using Red Devil 25.4 cm (10 in) duct

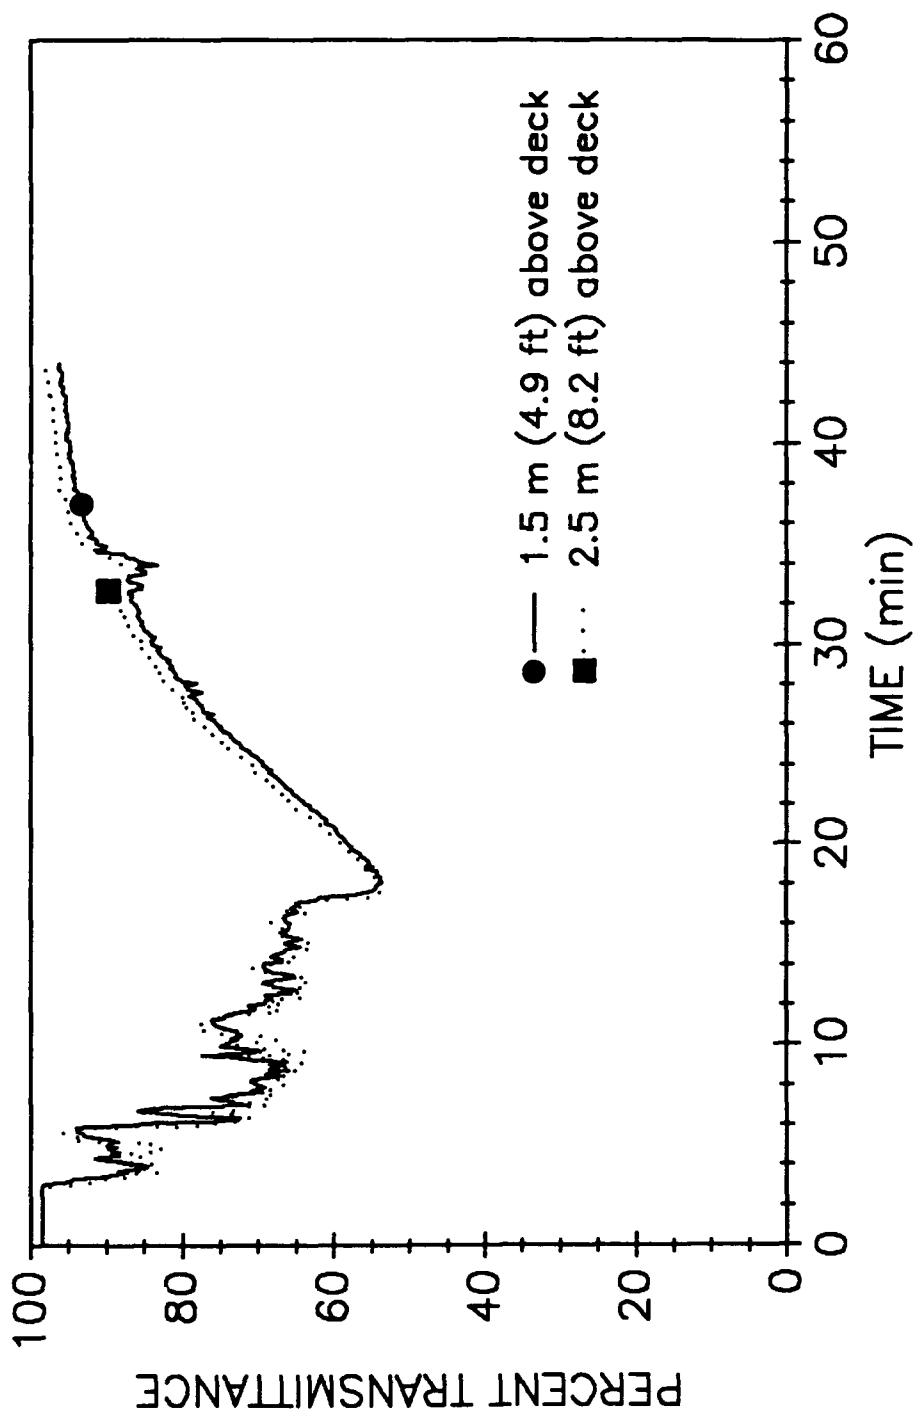
Fig. 26 - Percent transmittance in RICER 1 during FAN\_15  
using RAMFAN 345 kPa (50 psi)

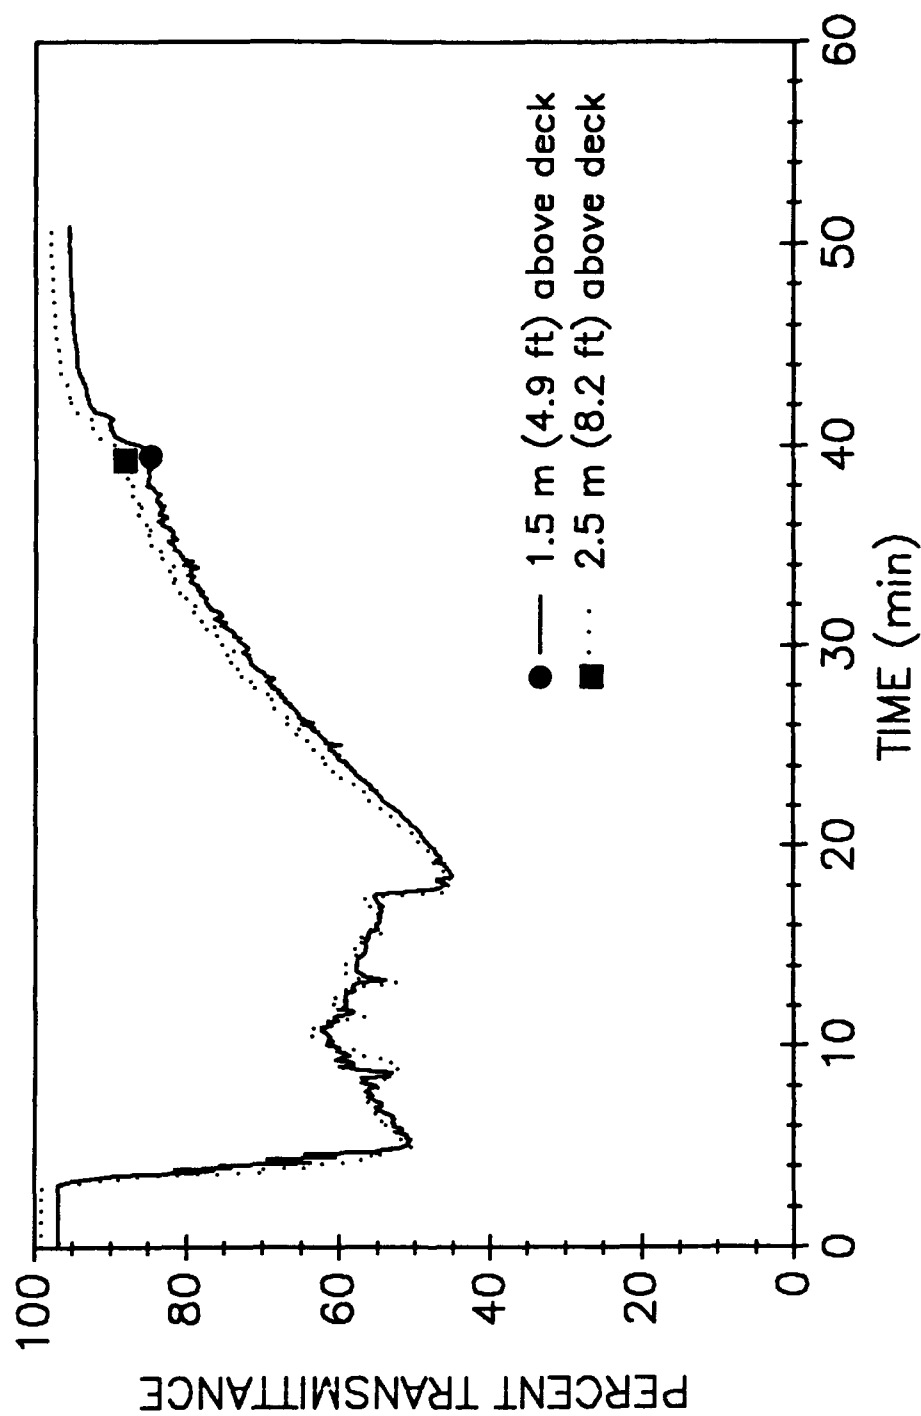
Fig. 27 - Percent transmittance in RICER 1 during FAN\_16  
using Red Devil 25.4 cm (10 in) duct

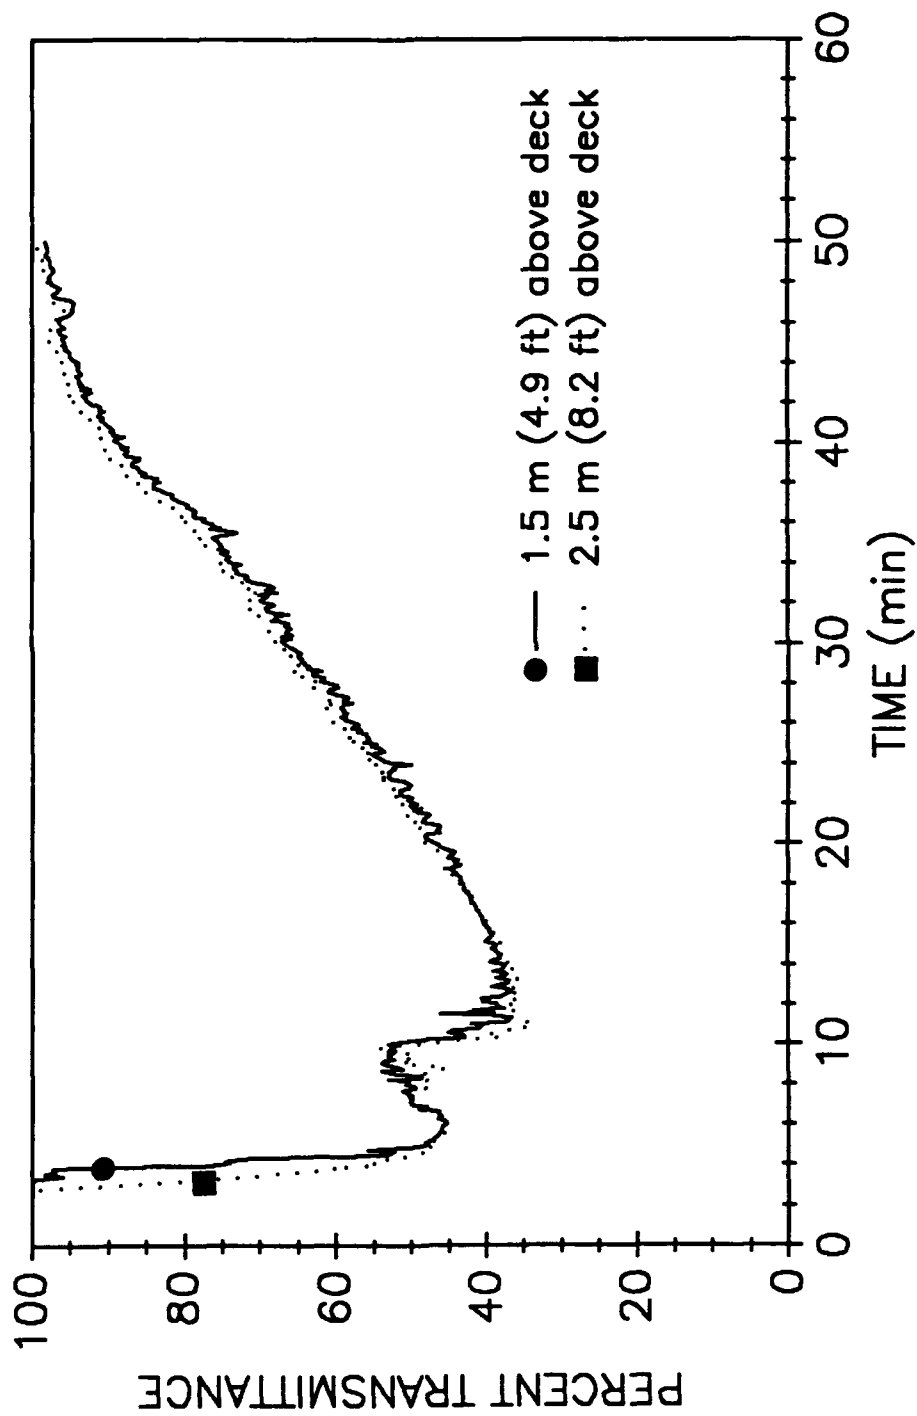
Fig. 28 - Percent transmittance in RICER 1 during FAN\_17  
using Red Devil 20.3 cm (8 in) duct

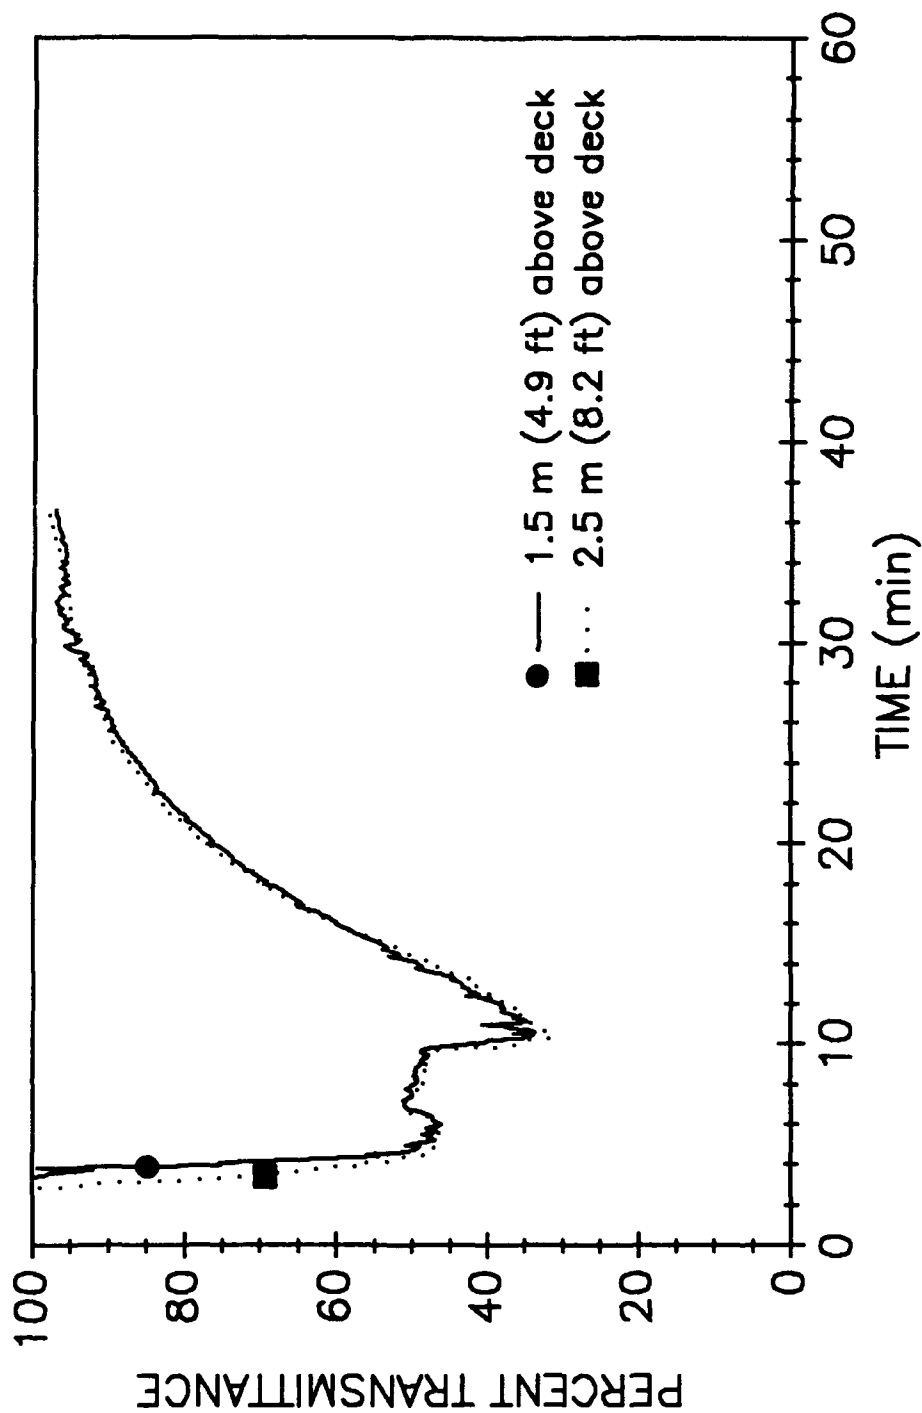
Fig. 29 - Percent transmittance in RICER 1 during FAN\_18  
using RAMFAN 956 kPa (140 psi)

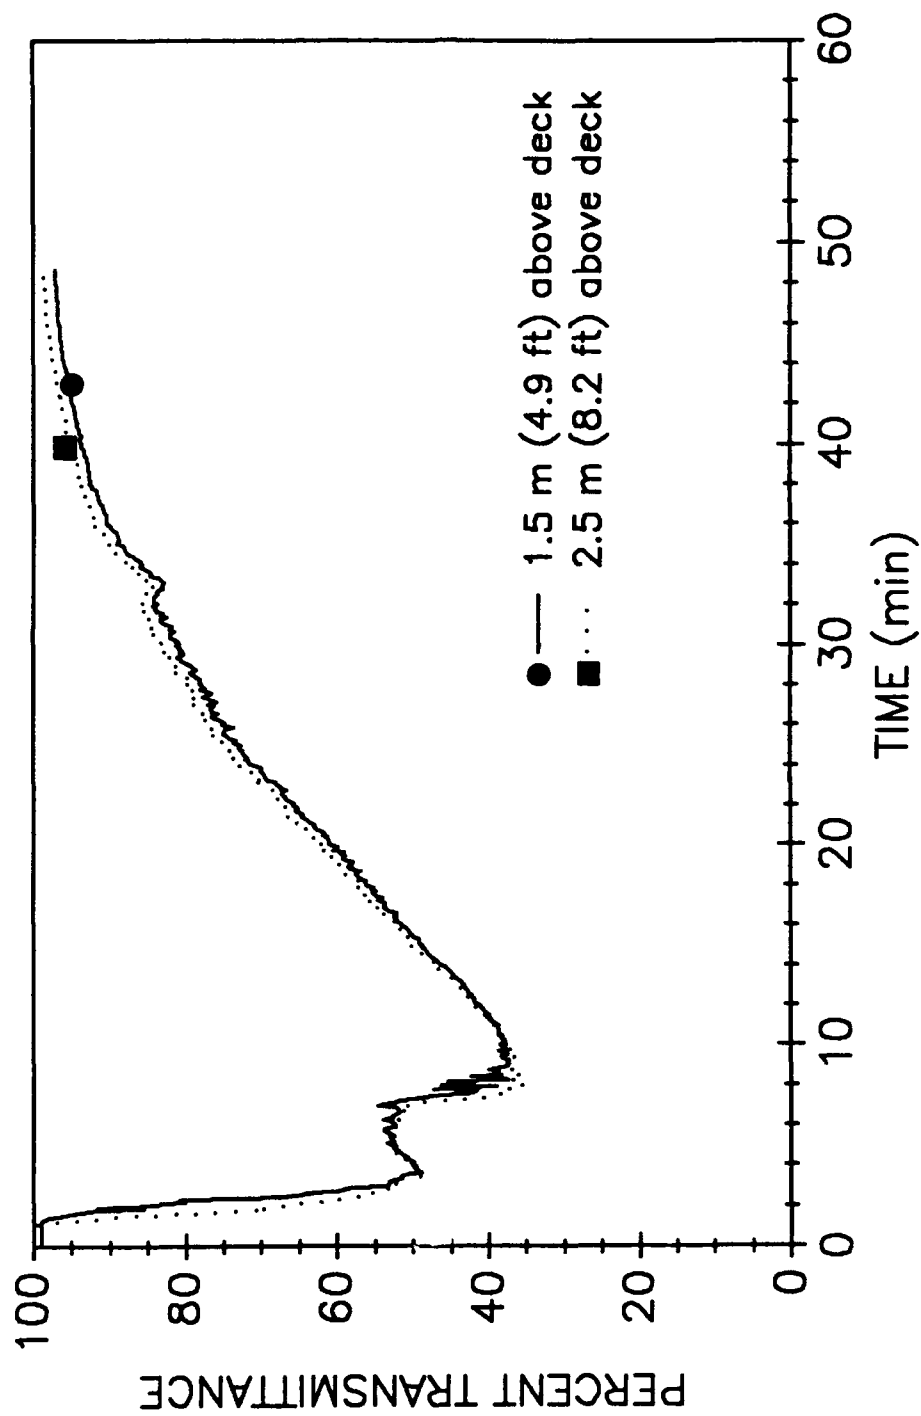
Fig. 31 - Percent transmittance in RICER 1 during FAN\_20  
using RAMFAN 345 kPa (50 psi)
